How to adjust the printhead on Primera Signature Cassette Printer

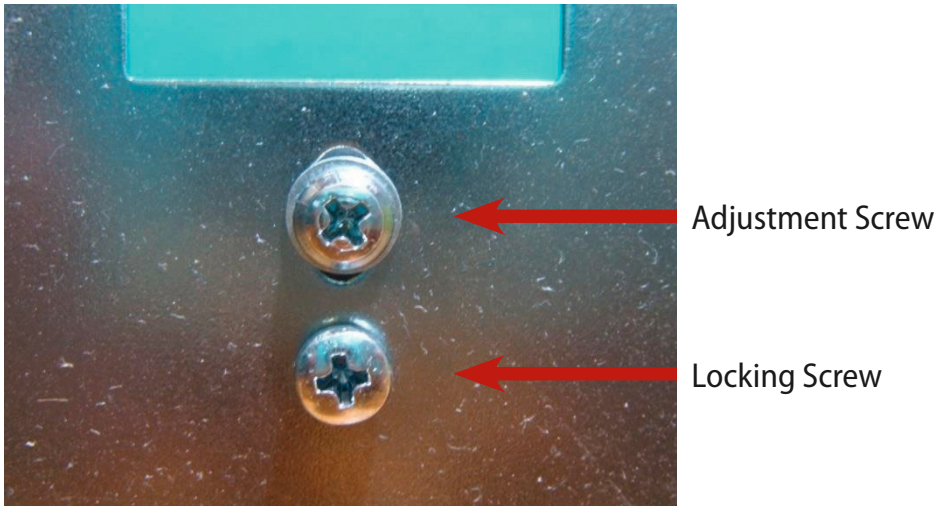
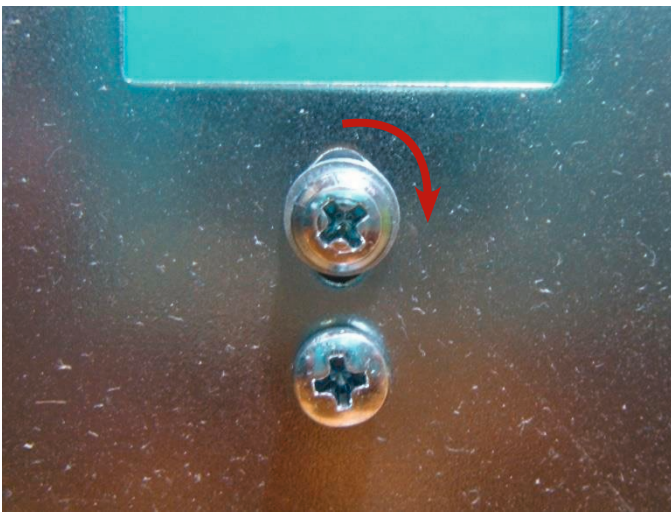
1. To Correct Ribbon Wrinkle and/or Ribbon Break

Ribbon wrinkle: Appears as small lines streaked through parts of the print.

Ribbon break: A tear in the ribbon can be a complete break or relatively small leaving the ribbon intact and causing only a portion of the print to appear smeared.

a.) Turn the adjustment screw Clockwise $\frac{1}{4}$ of a turn using the instructions below.

Fully back out the locking screw before turning the adjustment screw. Retighten the locking screw snugly (do not overtighten) after adjustment.

c.) If ribbon wrinkle or ribbon breaks still occur, continue making further adjustments $\frac{1}{4}$ of a turn at a time until it no longer occurs.

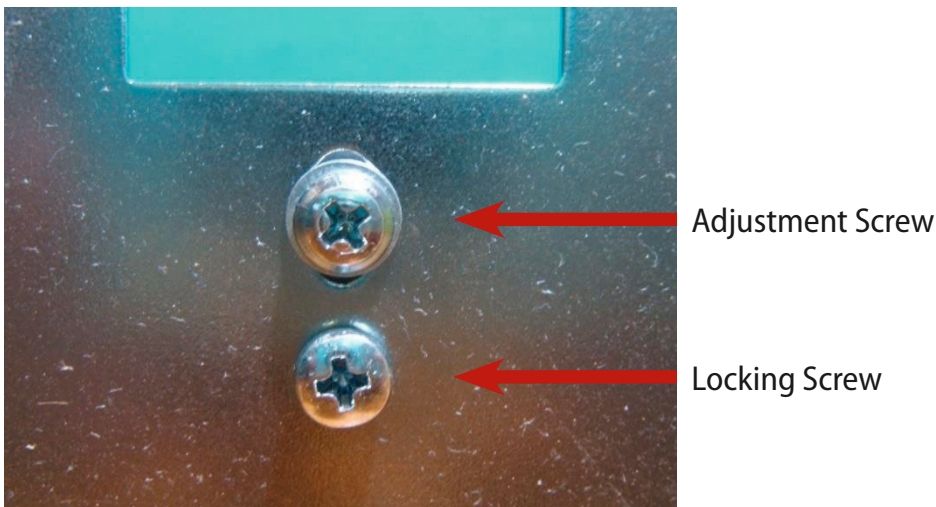
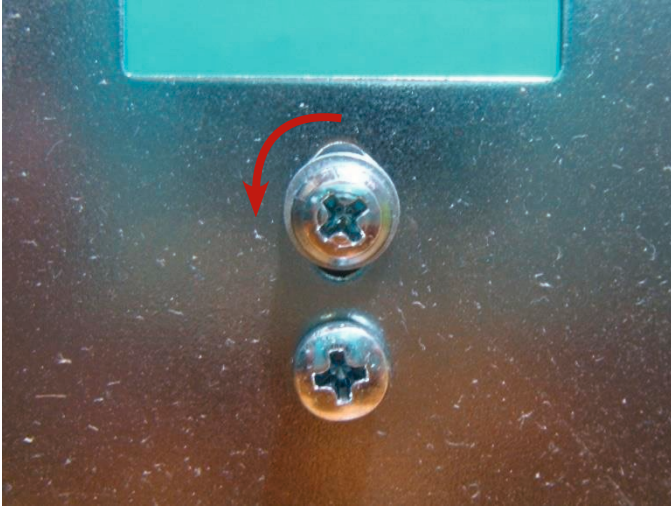
Quality is poor throughout entire width of print, with patches coming in very faded or speckled.

- a.) Turn the adjustment screw Counterclockwise $\frac{1}{4}$ of a turn using the instructions below.

Fully back out the locking screw before turning the adjustment screw. Retighten the locking screw snugly (do not overtighten) after adjustment.

Turn the adjustment screw counterclockwise to make the printed image darker.

c.) If the printed image is still light, continue making further adjustments $\frac{1}{4}$ of a turn at a time until the image quality is acceptable.
